# New PSU Sensor Design and Cable Seal Fabrication Procedures

M. D. JEVNACER AND J. L. TINS

February 9, 1982

NAVAL RESEARCH LABORATORY  
Washington, D.C.

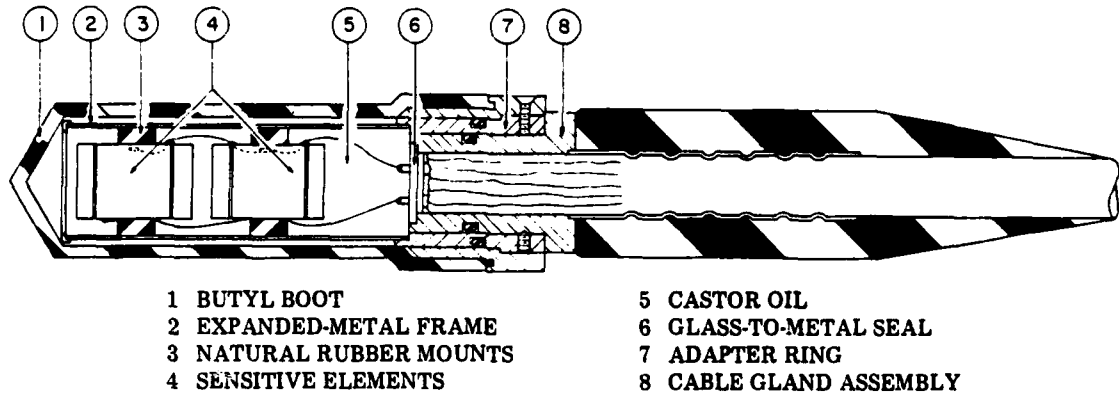
Fig. 1 — Section through an USRD type F50 transducer

Observations of numerous units that have been returned for repair show that two failure modes are most commonly encountered. The first failure mode is flooding of the interior of the sensitive elements with oil. In the five-year period 1976 to 1981, approximately 50% of the units had to have the sensitive elements rebuilt for this reason. The second is an electrical or mechanical failure of the glass-to-metal seal in the cable gland which caused oil leakage into the cable and a roll-off in sensitivity in the audio frequency range. In this same period, approximately 10% of the units required new cable glands. A less common failure mode, elements dislocated and leads broken due to rough use, occurred in 5% of the units in the same period. All of these problems have been solved by the changes described in this report.

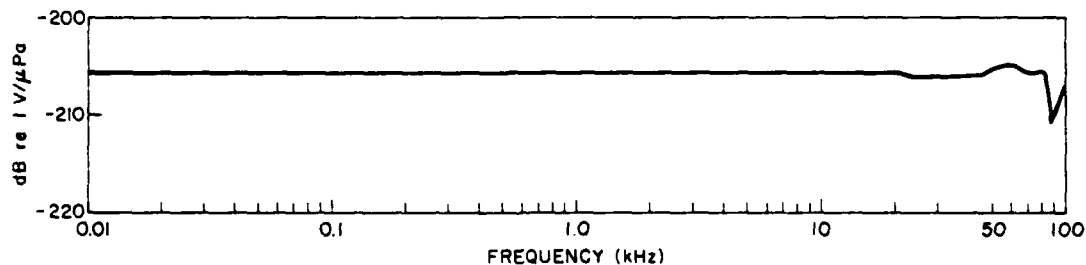
Fig. 6 — Free-field voltage sensitivity of an F50 transducer (open-circuit voltage measured at the end of a 30.5-m cable).

In January 1980, USRD Type F50, Serial No. 113, was constructed using the methods set forth in this report. This transducer has been calibrated in both the Lake Facility and the Anechoic Tank Facility. A typical free-field voltage sensitivity curve is shown in Fig. 6 and is identical over the normal operating range, within the accuracy of measurements, to an F50 that has not had the modified sensor installed.
